# PRE-DEMOLITION ASBESTOS SURVEY

240281, MCDONALD'S, BOONVILLE, MO

490 AMERICANA  
BOONVILLE, MISSOURI 65233

ECS PROJECT NO. 53:5554-A

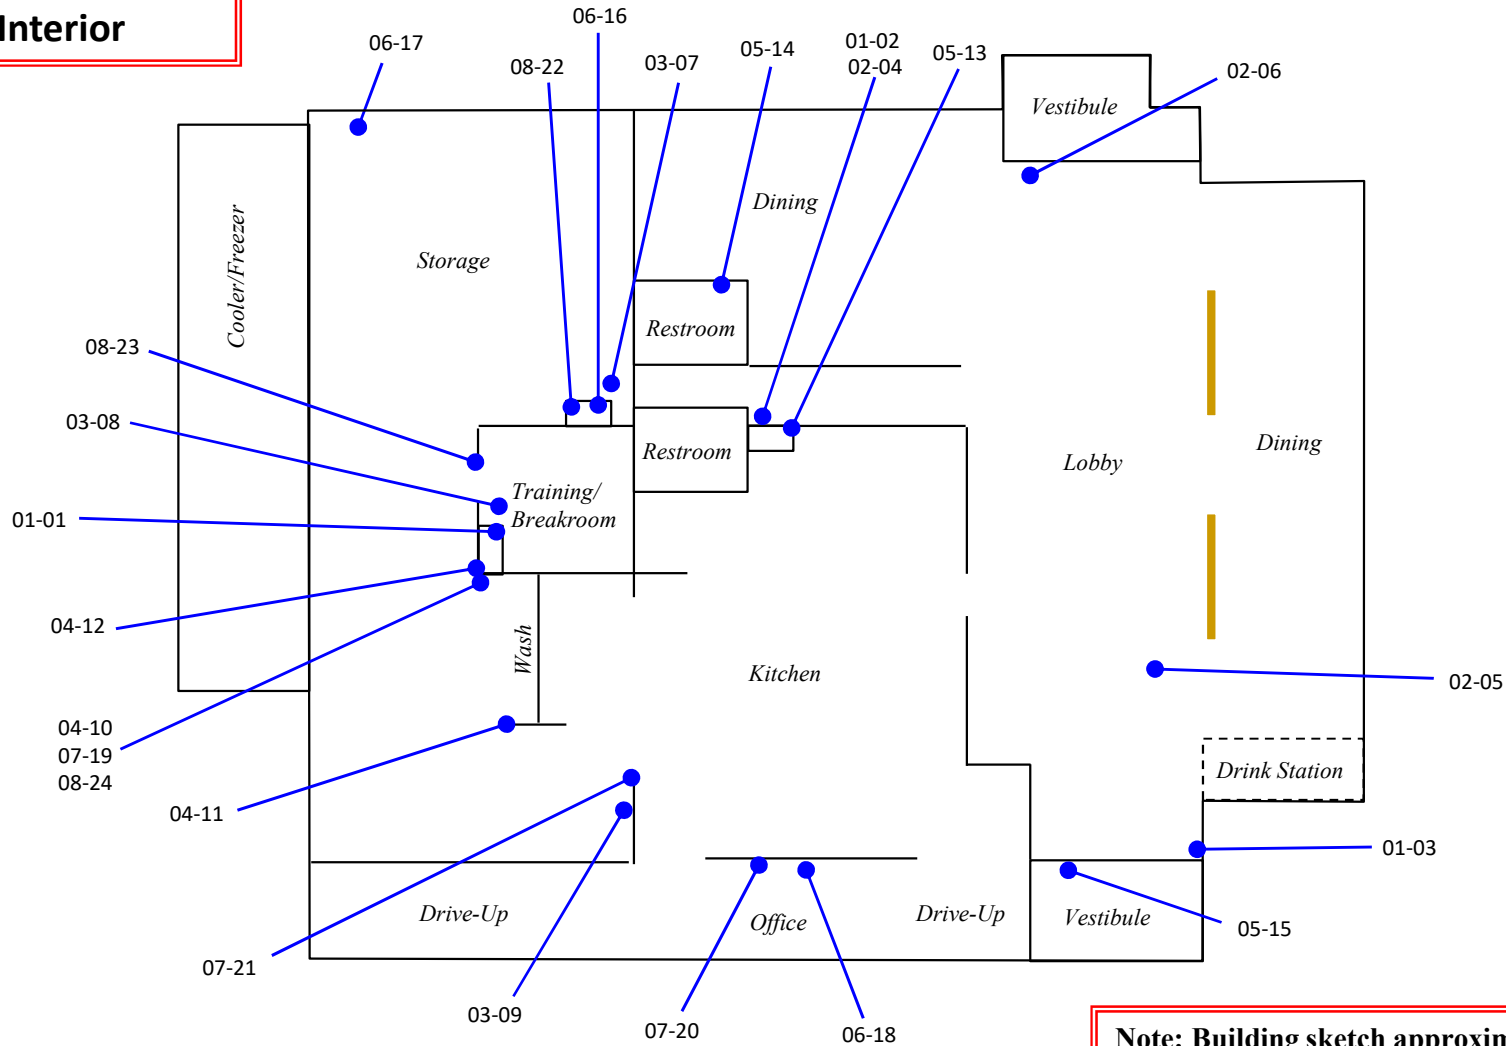
Asbestos Sample Location Diagram  
 ECS Project 53:5554-A  
 Sampled: May 30, 2025

**Note: Building sketch approximates significant areas. Not all features are depicted.**

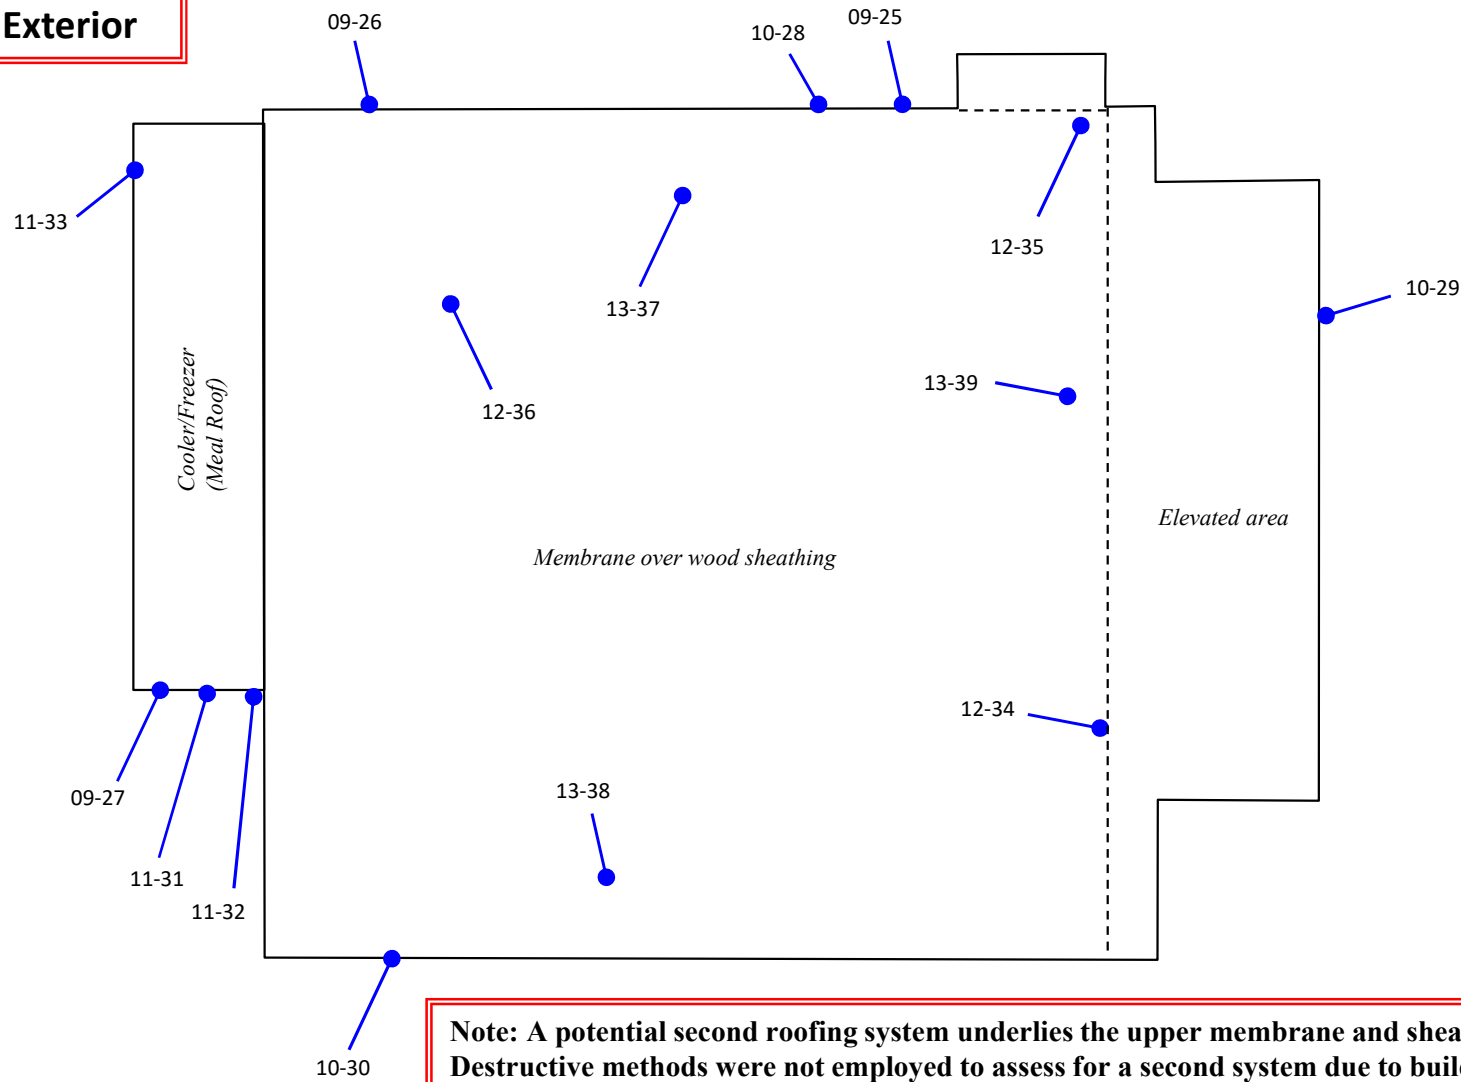
Asbestos Sample Location Diagram  
 ECS Project 53:5554-A  
 Sampled: May 30, 2025

**Note: A potential second roofing system underlies the upper membrane and sheathing. Destructive methods were not employed to assess for a second system due to building occupancy.**

**ECS was unable to sample the the original roofing system that is suspected to underlie the outer membrane system; therefore, the underlying roofing materials are considered Assumed ACM. ECS recommends this material be sampled prior to demolition of the building.**

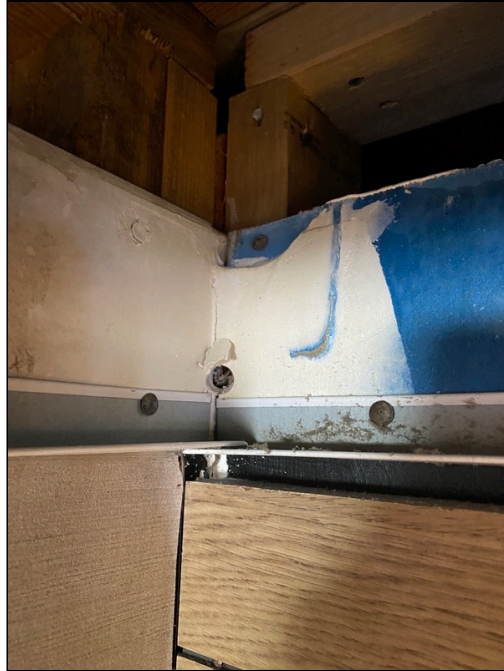
1 - HA-01: Non-ACM drywall and joint compound

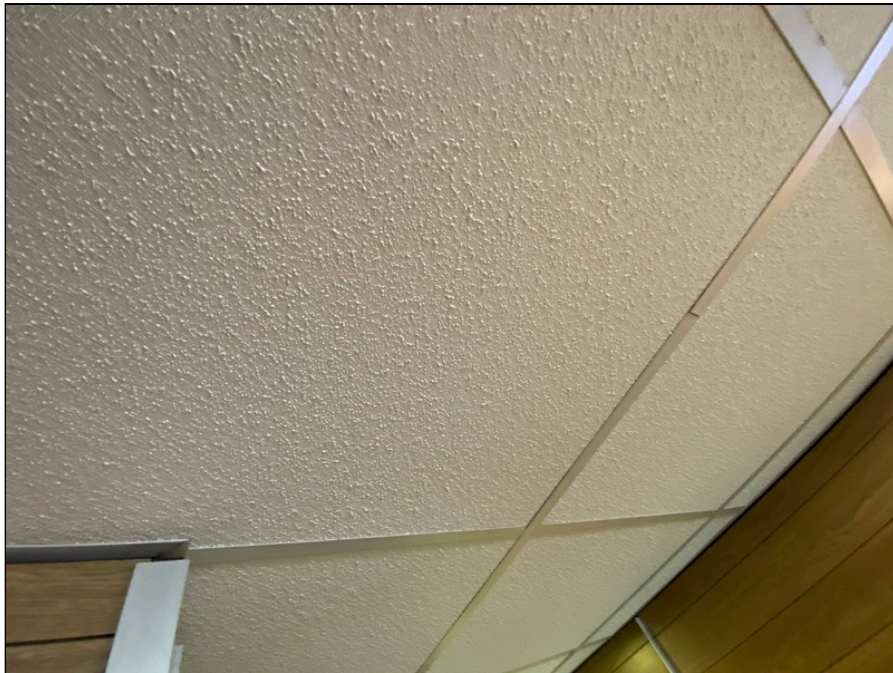
2 - HA-02: Non-ACM 2-ft by 2-ft textured ceiling tiles

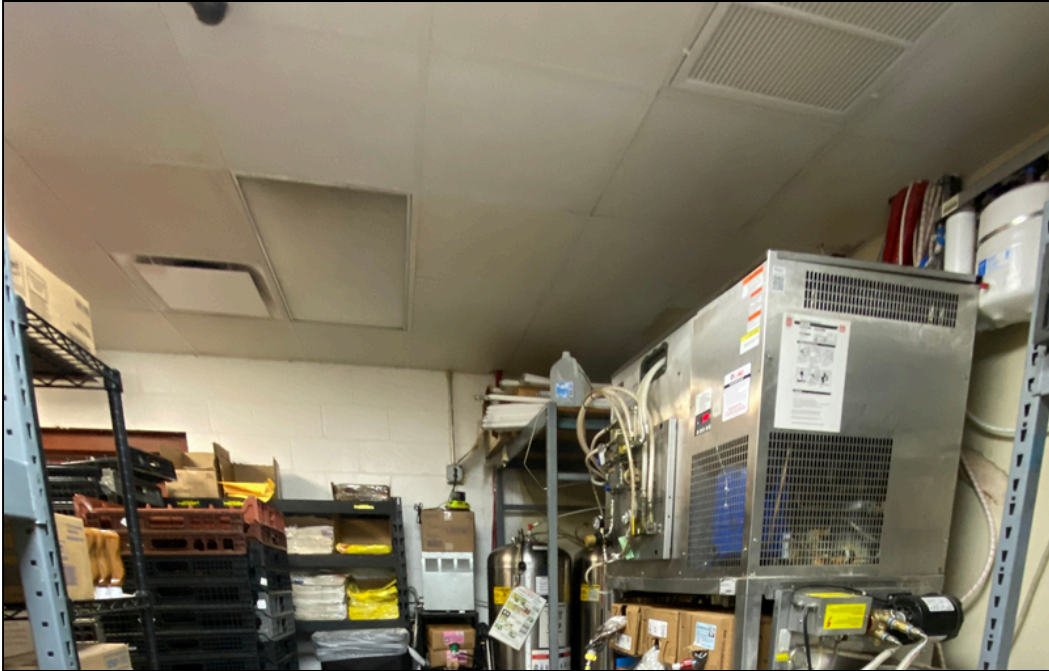
3 - HA-03: Non-ACM 2-ft by 4-ft fire resistant ceiling tile

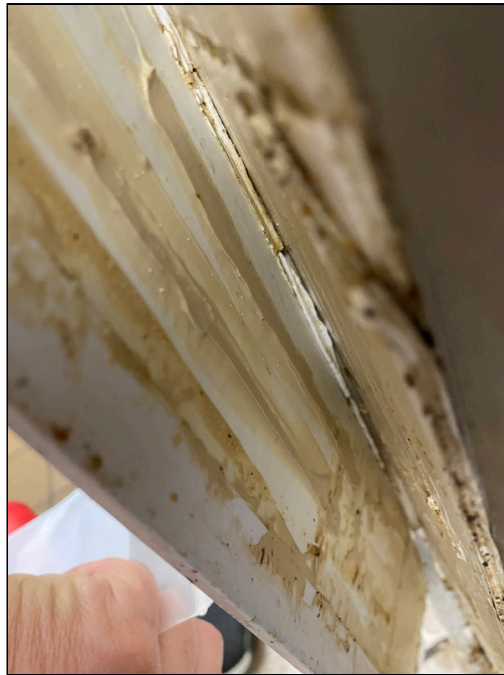
4 - HA-04: Non-ACM FRP mastic

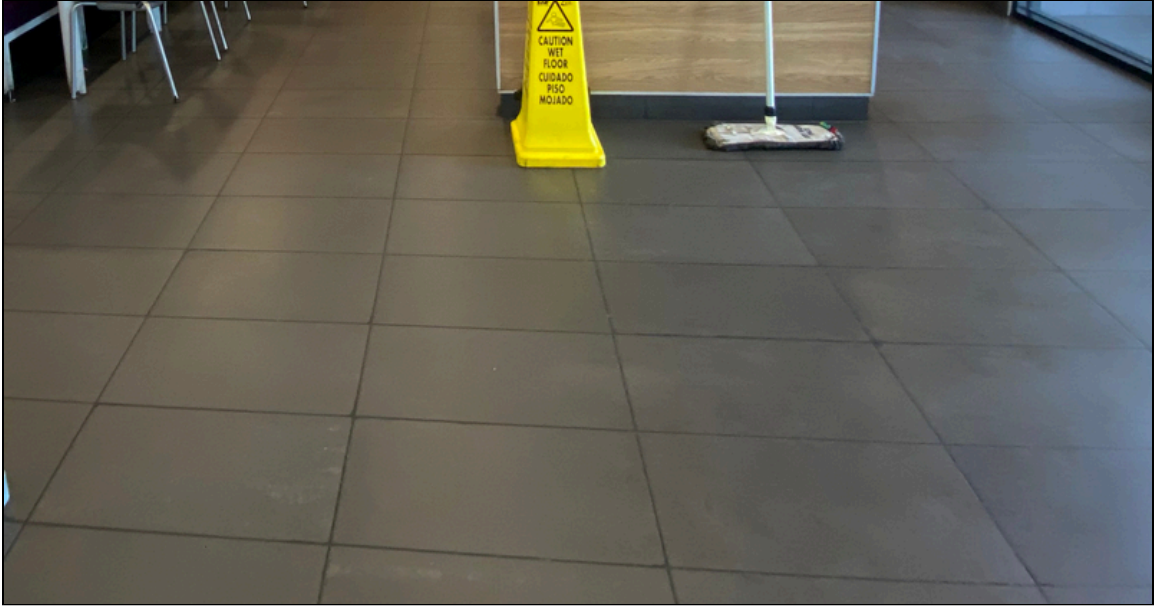
5 - HA-05: Non-ACM gray-black grout in FOH

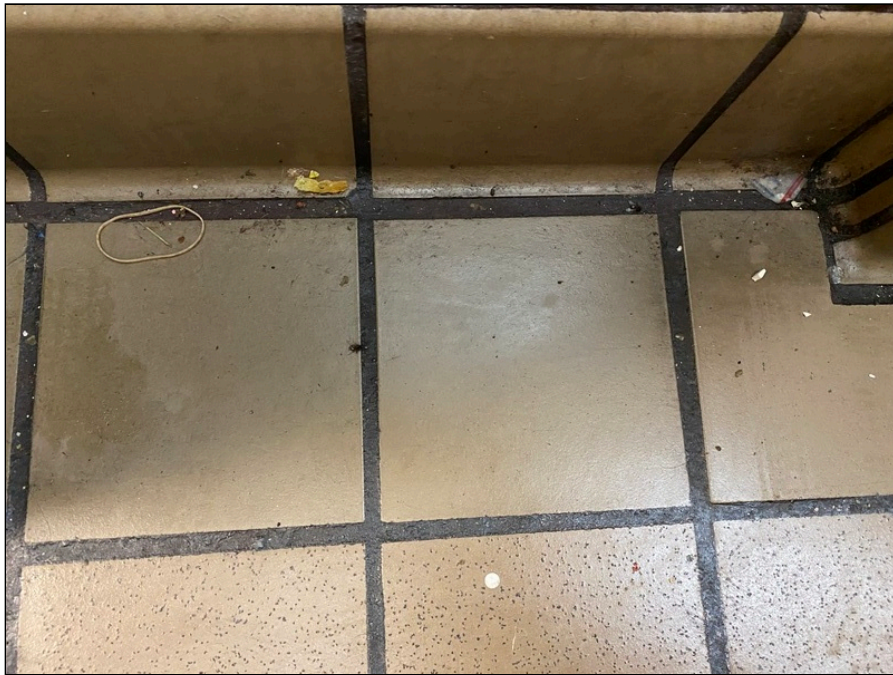
6 - HA-06: Non-ACM black tile grout in BOH

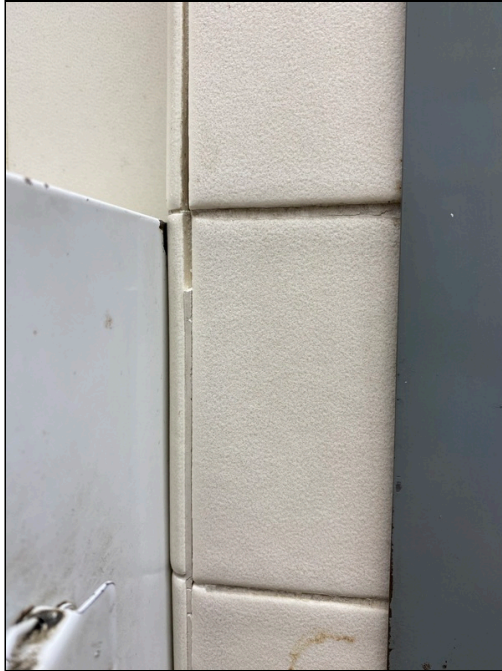
7 - HA-07: Non-ACM white tile grout

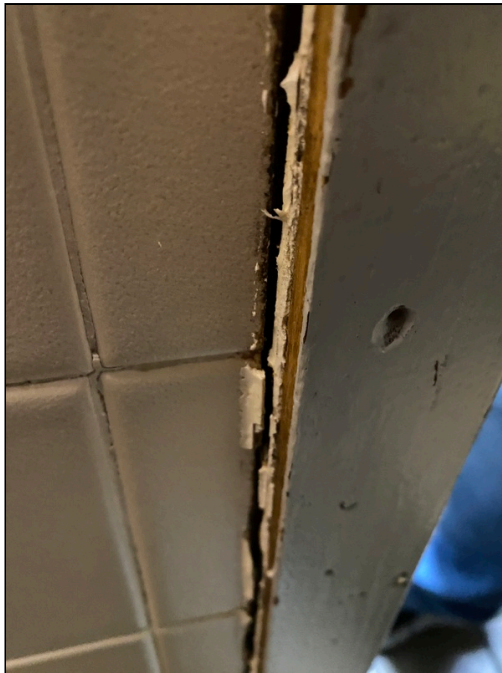
8 - HA-08: Non-ACM white caulk around BOH interior door frames and at FRP panel seams

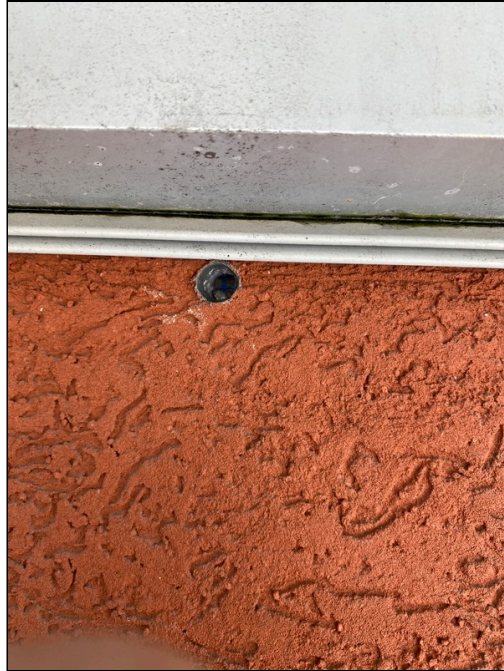
9 - HA-09: Non-ACM EIFS exterior building finish

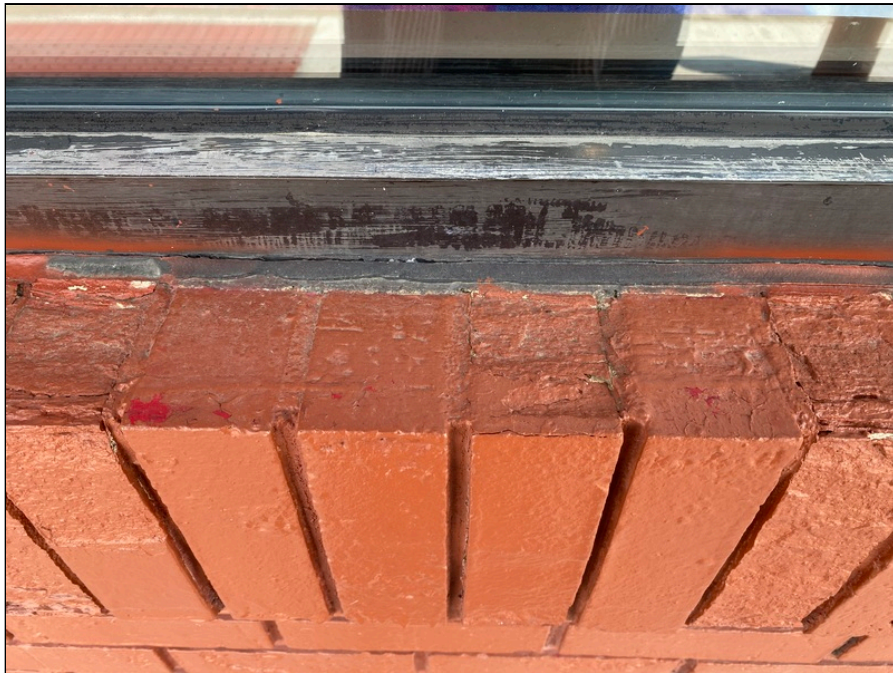
10 - HA-10: Non-ACM black caulk surrounding window exteriors

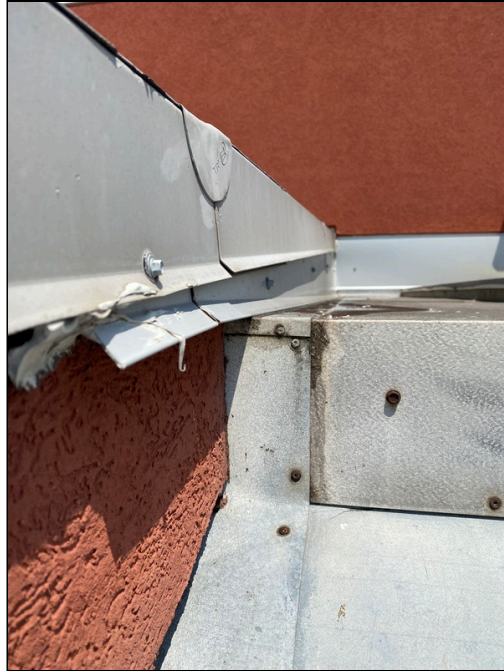
11 - HA-11: Non-ACM light gray caulk on cooler roof

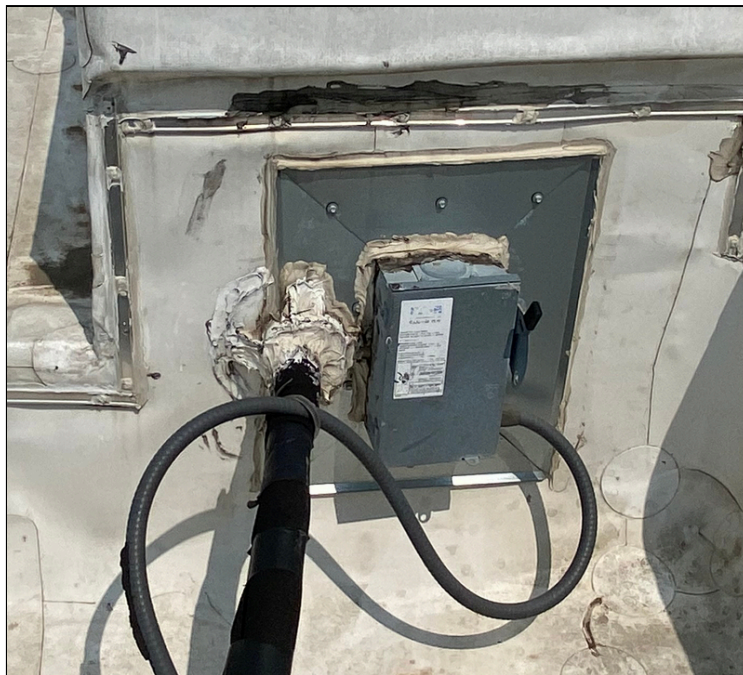
12 - HA-12: Non-ACM white caulk on roof penetrations

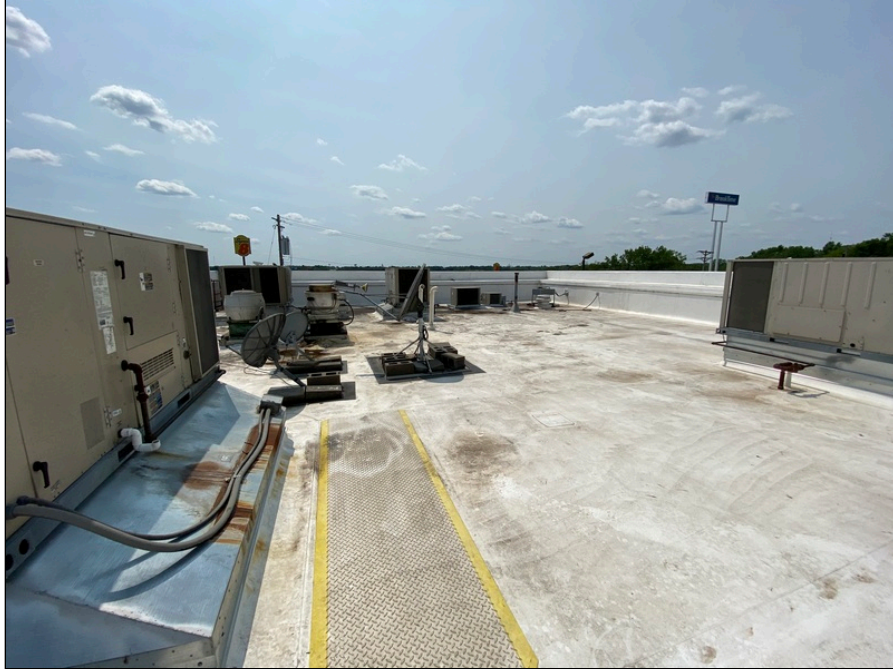
Additionally, the 5,000± square feet membrane system (membrane over wood sheathing) is believed to overlay the original roofing system. The underlying original roofing materials were not accessible at the time of the survey due to the need for destructive methods to access the materials. Therefore, the underlying roofing materials should be sampled and analyzed for asbestos prior to the proposed demolition.

13 - HA-13: Non-ACM membrane roofing system (may be overlaying an inaccessible roofing layer)
